Effects of Electrolyte Impurities in Chlorate Cells

Richard A. Kus
Senior Research Chemist
ELTECH Systems Corporation
Fairport Harbor, Ohio USA

16th Annual Chlorine/Chlorate Seminar

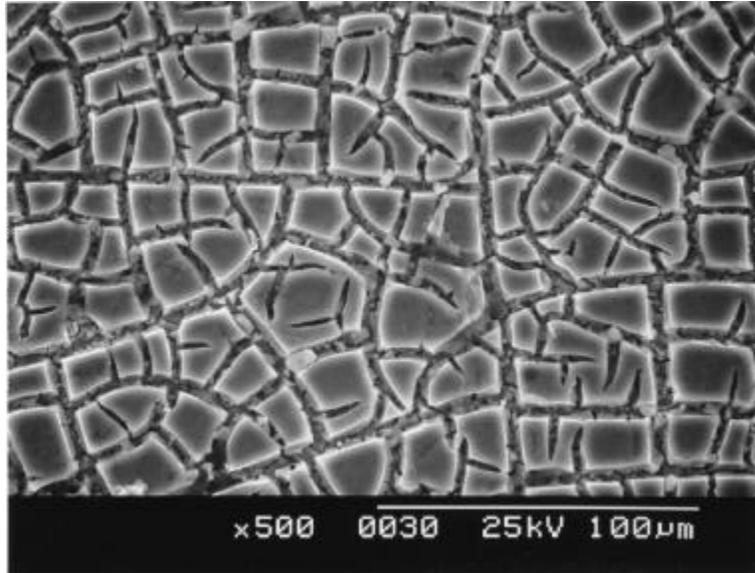
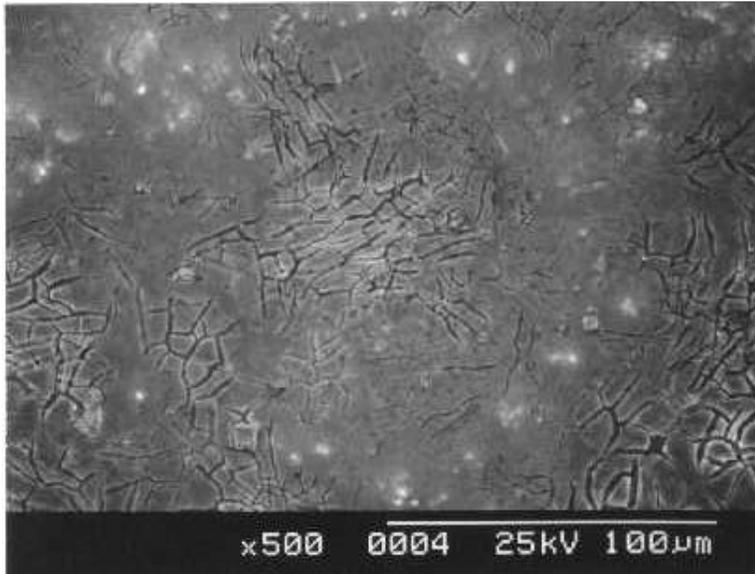
Figure 2

EC100

EC120

First, it is appropriate to review some background on DSA anode technology. DSA are a unique combination of valve metal, precious metal oxides catalysts, chemically bound to a valve metal substrate (Figure 1). For most commercial applications the valve metal of choice is titanium. A valve metal is a metal that will passivate (form a protective oxide film on exposed metallic surfaces) upon anodic polarization in aqueous electrolytes. This property gives the valve metals a remarkable corrosion resistance in many operating environments, but also prevents the use of the valve metal, independently, as an anode without the addition of a properly formed catalytic layer. The protective action of this oxide film in many applications is sufficient to allow reuse of the substrate when catalyst failure has occurred. A Scanning Electron Microscope (SEM) surface view compares that of EC100 and EC120 (Figure 2). EC100 reveals the mudcracked, high surface area characteristic of chlorine/chlorate DSA. The EC120 has a smoother morphology, of which the benefits will be described later.

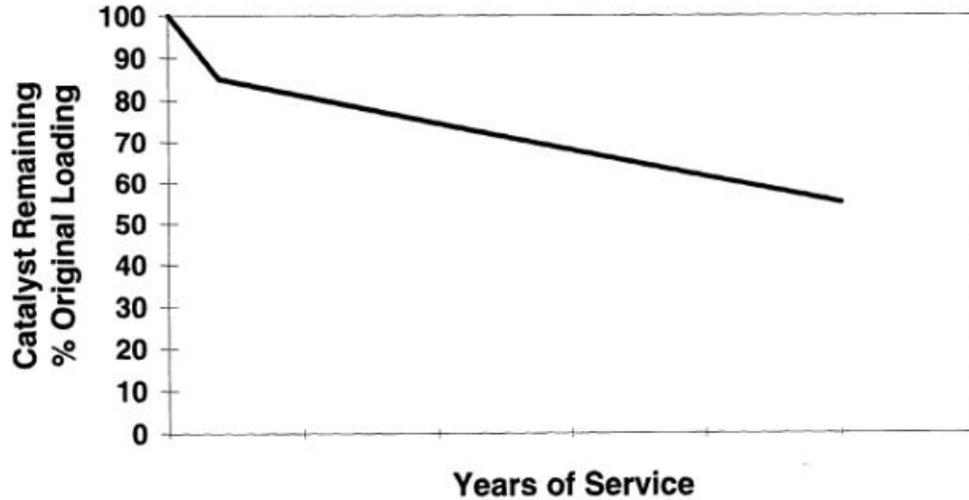
Figure 7

**Normal Coating Wear Rate
for Chlorate DSA**

Brine impurities directly and indirectly affect the catalyst wear mechanism. Normal DSA performance is characterized in Figure 7. Typically a 10-15% initial loss of catalyst is observed over the first six months to a year of operation, followed by a gradual wear with time throughout the useful life of the coating. No change in voltage performance is expected until below 20% of original loadings are present. As wear continues, a gradual increase in operating voltage will be observed as wear exposes uncoated areas of the substrate. Current will shift to remaining active areas, locally increasing current density and observed operating voltage.

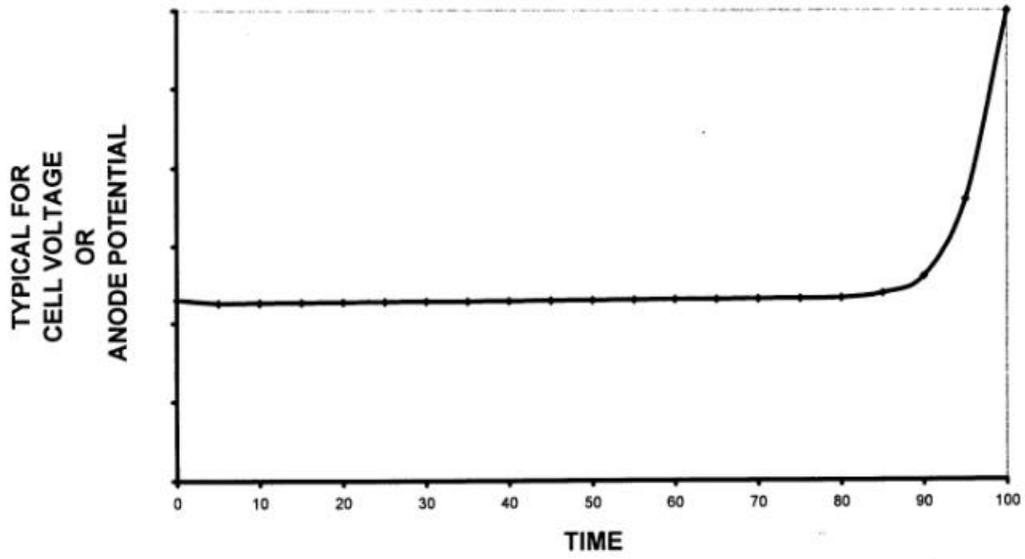
Figure 9
TYPICAL POTENTIAL TIME CURVE

A typical potential time curve for DSA anodes operated to passivation failure is similar for both chlorine and oxygen type anodes (Figure 9). The difference between the two is reflected in the time axis. For oxygen coatings at 3 kA/m^2 the time axis can be years. For chlorine coatings, producing only oxygen, the axis is measured in hours.

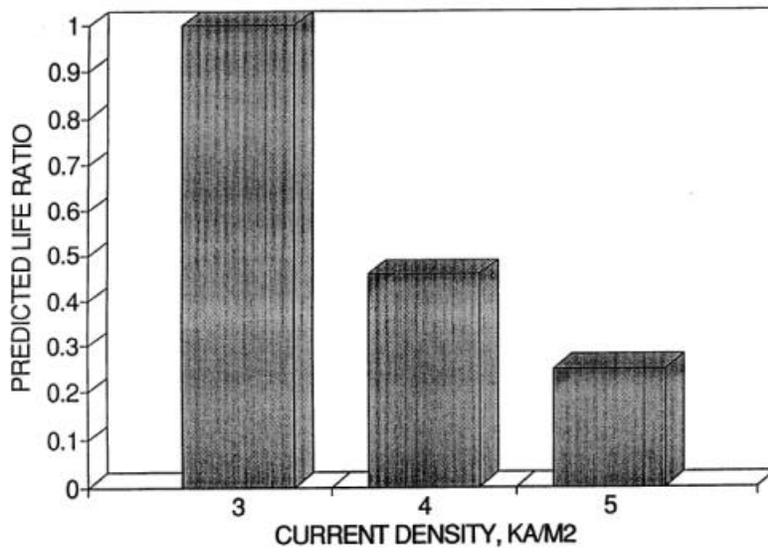
Figure 10
IMPACT OF EXCEEDING DESIGN CONDITIONS ON LIFE EXPECTANCY

The exponential relationship between expected lifetime and the rate of oxygen production can result in rapid failure of a chlorine DSA when operation at conditions favoring increased oxygen production are encountered. If a catalyst loading is established for operation at a specified maximum rate of oxygen generation using 3 kA/m^2 but is operated at 4 or 5 kA/m^2 by design or through poor current distribution, the forecast life is significantly reduced as illustrated (Figure 10).

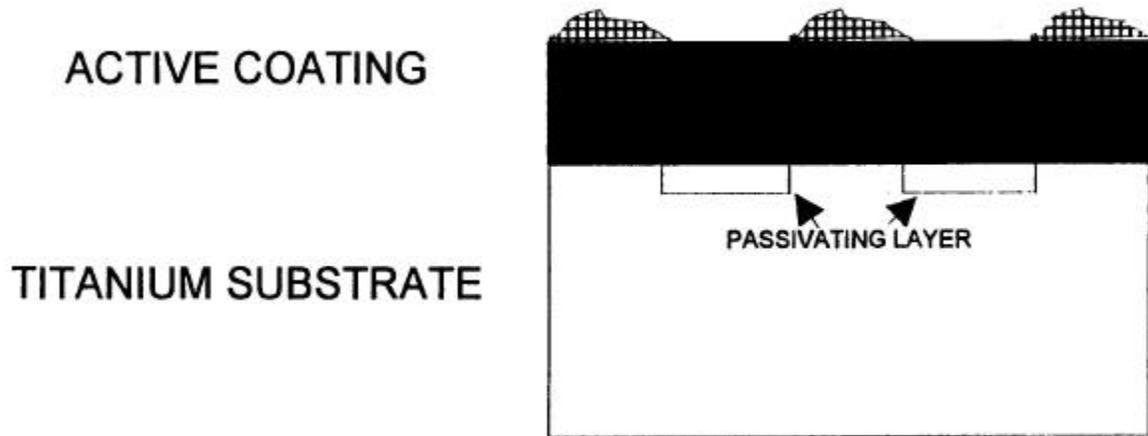
Figure 11

BLINDING DEPOSITS

The most frequently encountered effect of brine impurities on DSA performance is the formation of blinding deposits. Both organic and inorganic deposits have been encountered over the years. The inorganic deposits can be the result of chemical precipitation reactions when solubility product limits are exceeded or may be electrochemically oxidized at the anode. The high surface area DSA catalyst effectively binds the deposit, blocking solution access to the surface. Failure to remove gross surface deposits can lead to an acceleration of the passivation mechanism (Figure 11).
