LA-7019-MS  
Informal Report

Issued: November 1977

## Examination of Copper or Nickel Coats on W-Base Composites

E. G. Zukas

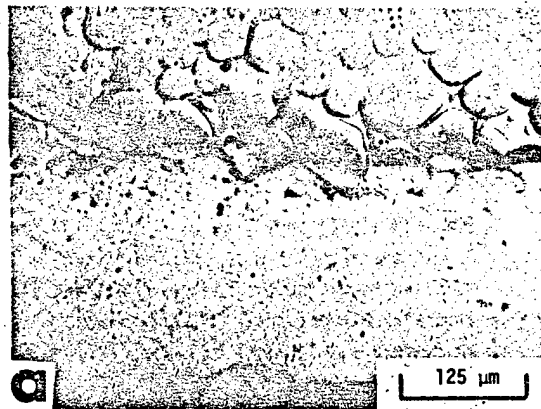
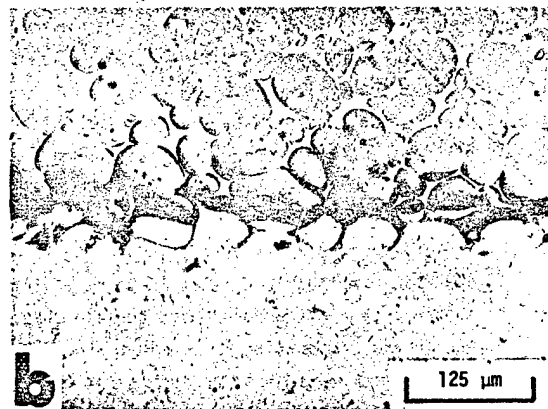
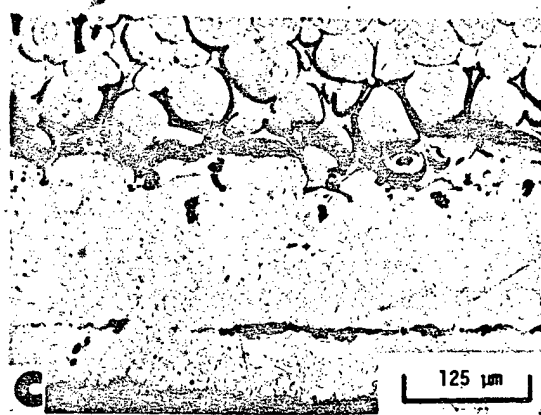
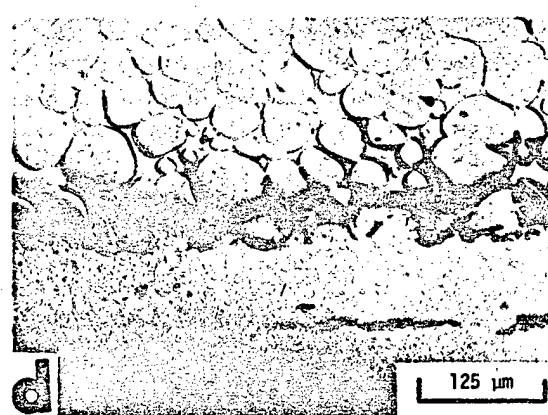
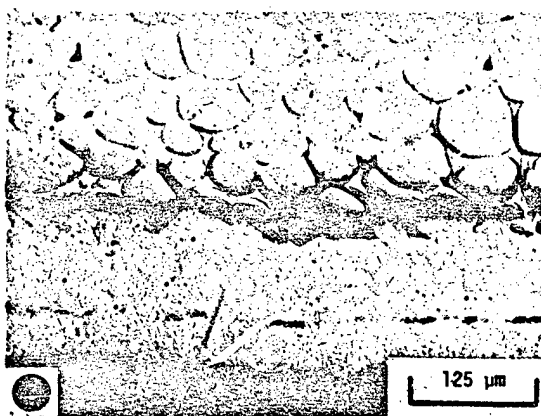
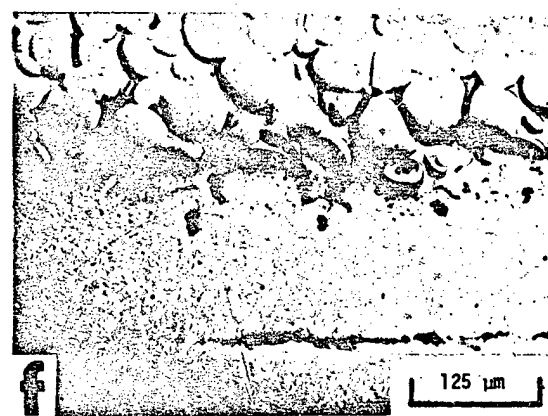
Fig. 1. Representative microstructures of the composite--copper junction showing bonding.

coats made it impossible to get rid of the polishing relief. Thus, all photomicrographs are of the specimens in the as-polished condition. Typical photomicrographs of the copper-coated composite are shown in Figs. 1 and 2. There are a number of pores in the copper, and a demarcation line about 70  $\mu\text{m}$  from the coat surface indicating that perhaps the coating process was stopped and restarted (perhaps after checking coat thickness). Surprisingly, this boundary remains after heat-treatment at 923 K, whereas the boundary between the copper coat and composite matrix is not readily apparent. The base composite contains a few pores, but generally appears to be reasonably sound. However, as reported earlier,<sup>1</sup> the bend ductility angle was only 14° for the uncoated specimen, whereas the coated specimen passed through the bend-test fixture without fracturing. Specimens coated with nickel, and heat-treated for 1 h at 1223 K are shown in Figs. 3 and 4. In these specimens, 0.5% Pt was substituted for 0.5% W. These specimens contained quite a bit of porosity, with many pores on the surfaces after the specimens were machined and polished. The bend ductility angle for the uncoated material was 16°, not significantly different from the relatively pore-free material. The heat-treated specimens passed through the bend-test fixture without fracturing. The nickel coat, which appears to have alloyed with the composite matrix, spans the gaps at the pores, thereby decreasing their effectiveness as stress raisers and reducing their tendency to promote fracture.

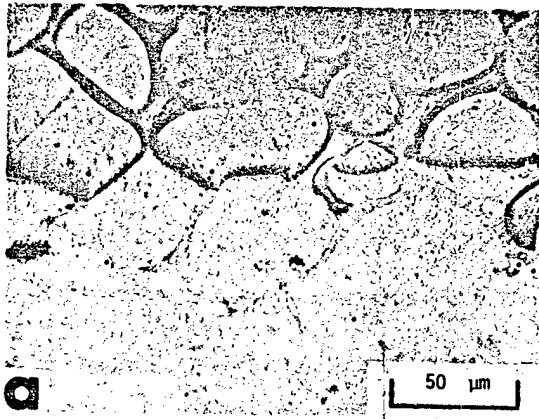
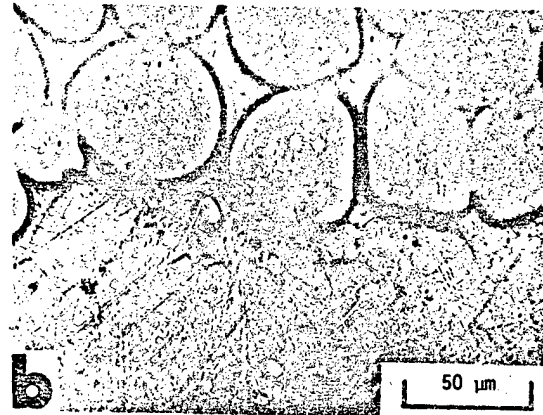
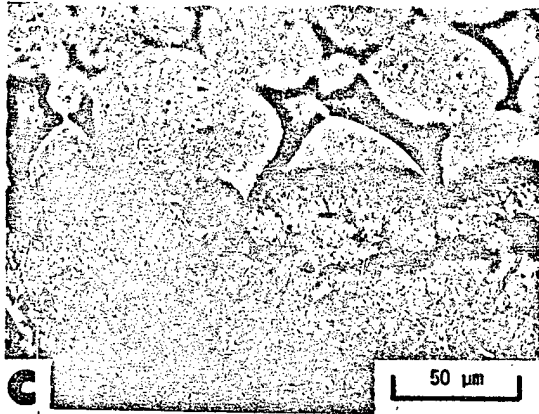
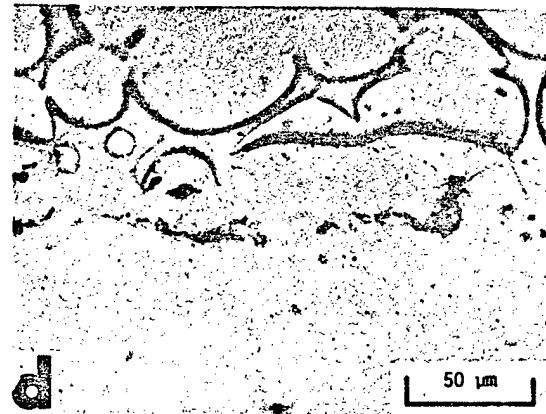
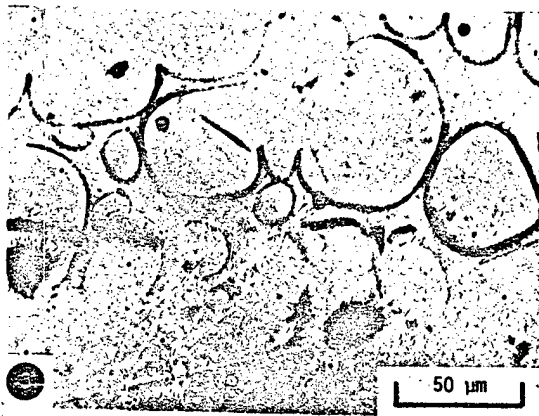
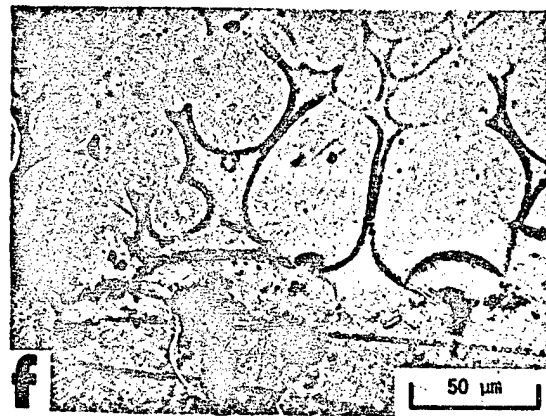
Fig. 2. Additional microstructures of the composite--copper junction.

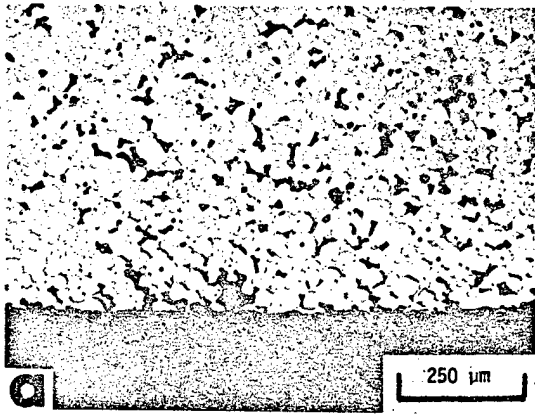
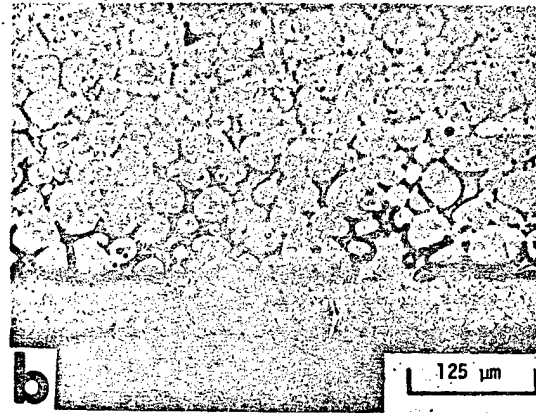
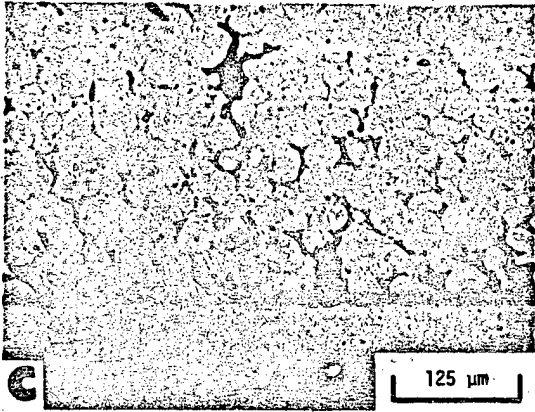
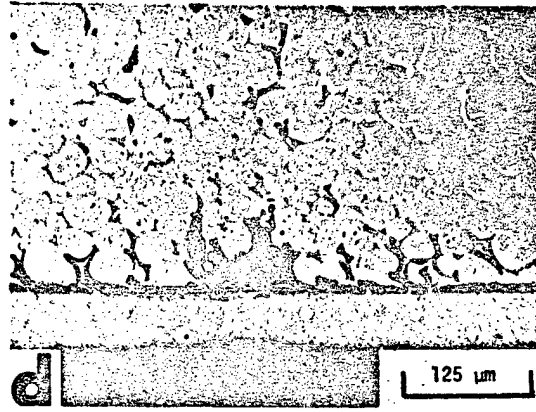
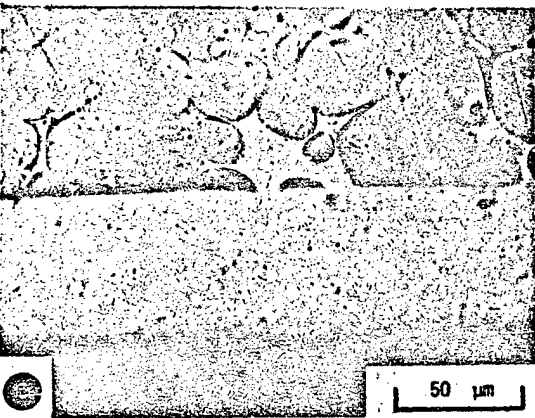
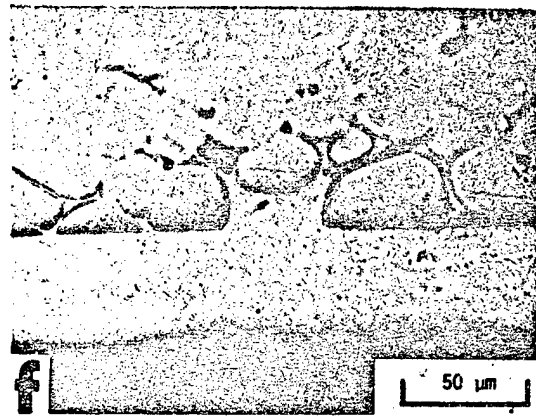
Fig. 3. Representative microstructures of the composite--nickel junction showing bonding as well as spanning of pores by the coat.

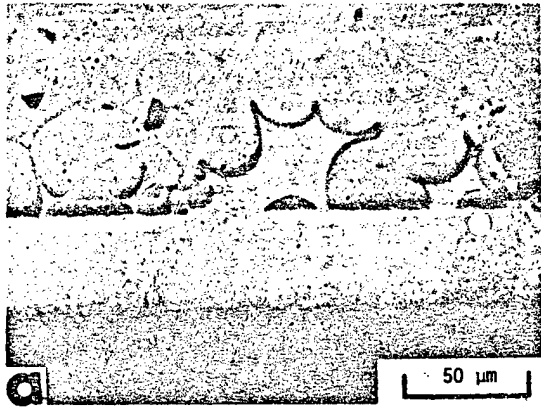
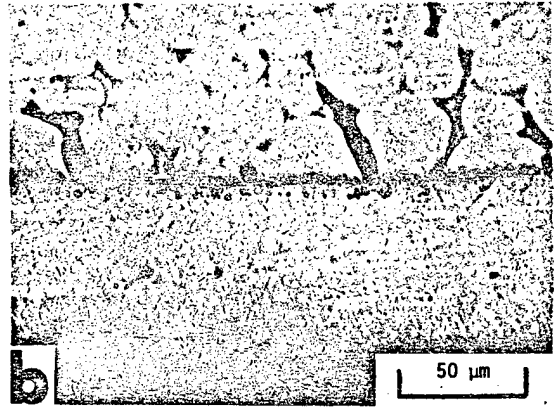
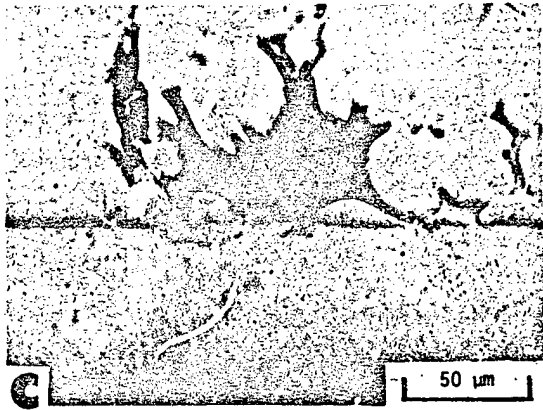
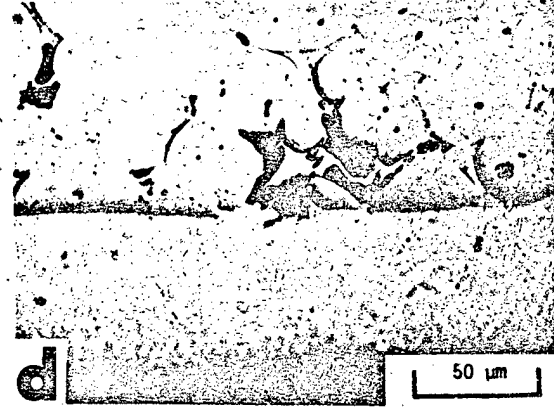
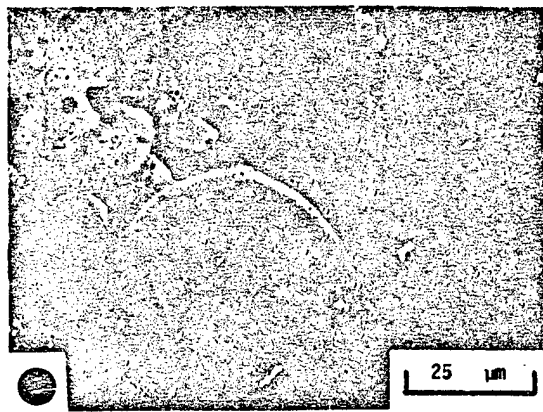
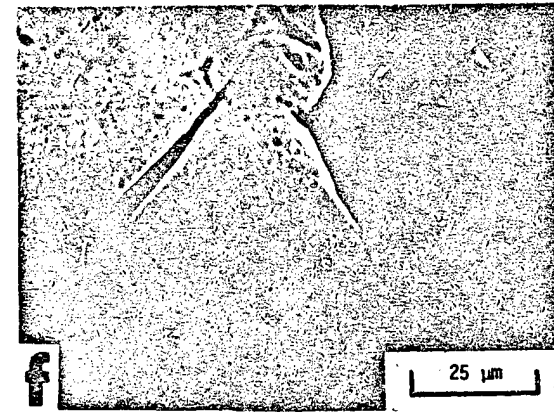
Fig. 4. Additional microstructures of the composite--nickel junction.

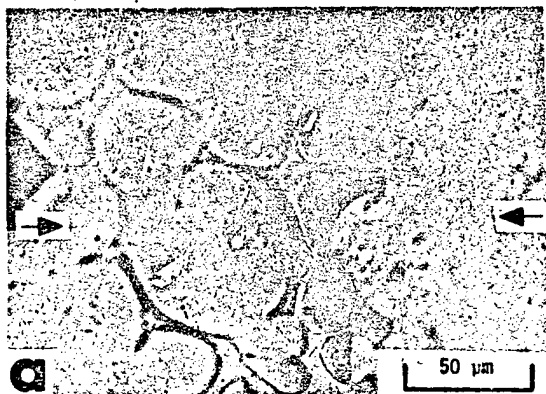
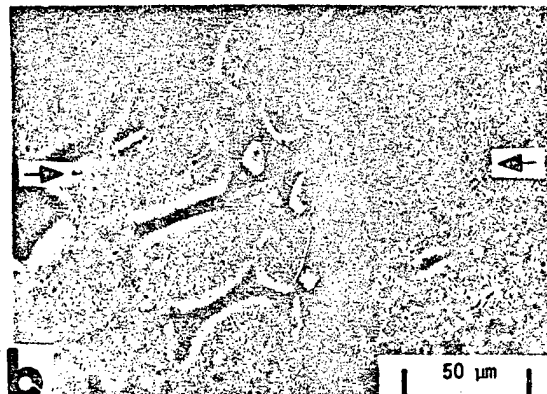
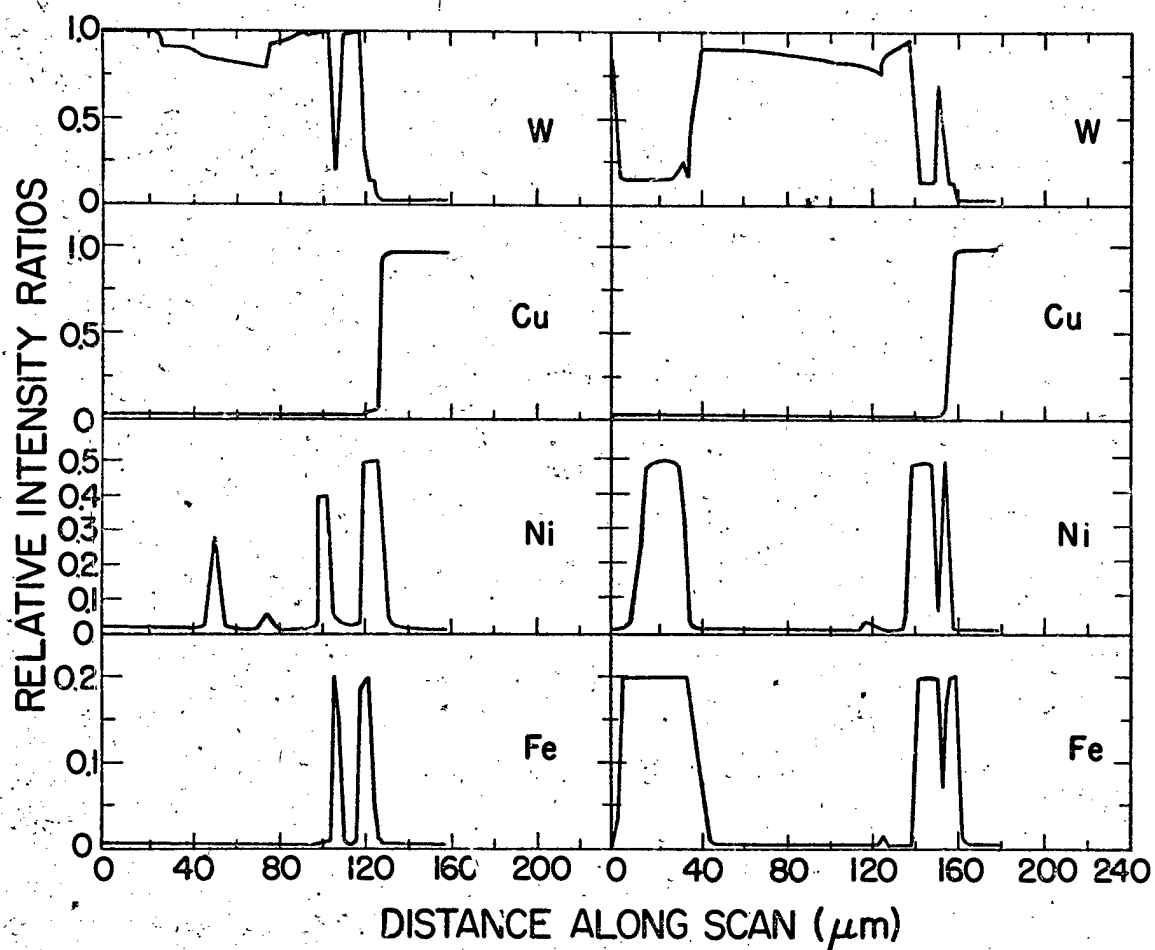
Fig. 5. Microprobe analysis of scans #1 and #2 across composite--copper junction.

Eight individual microprobe scans for the 95% W-35.5% Ni-1.5% Fe composite coated with copper followed by heat-treating in vacuum for 1 h at 923 K are shown in Figs. 5 through 8. Arrows are used to denote the scan path but do not define the starting point. Since the spheroids are essentially pure W, the scan paths can be matched to position in the structure. The interdiffusion appears to be between the nickel in the matrix and the copper coat. The width of the alloy band is about 6  $\mu\text{m}$ , in fair agreement with what should be expected based on the diffusivity for the times and temperatures used. The important point here is that there is chemical bonding between the copper coat and the base composite.

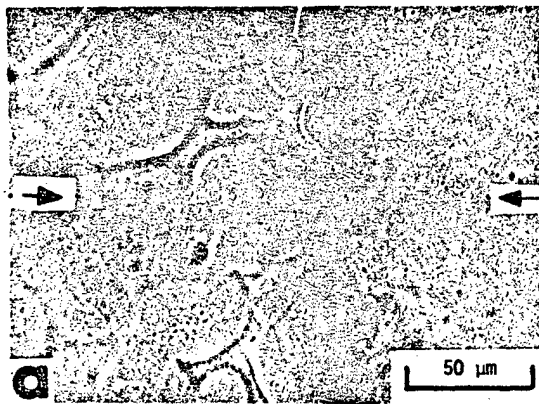
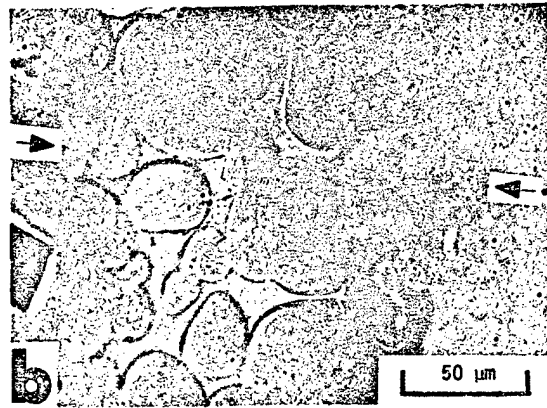
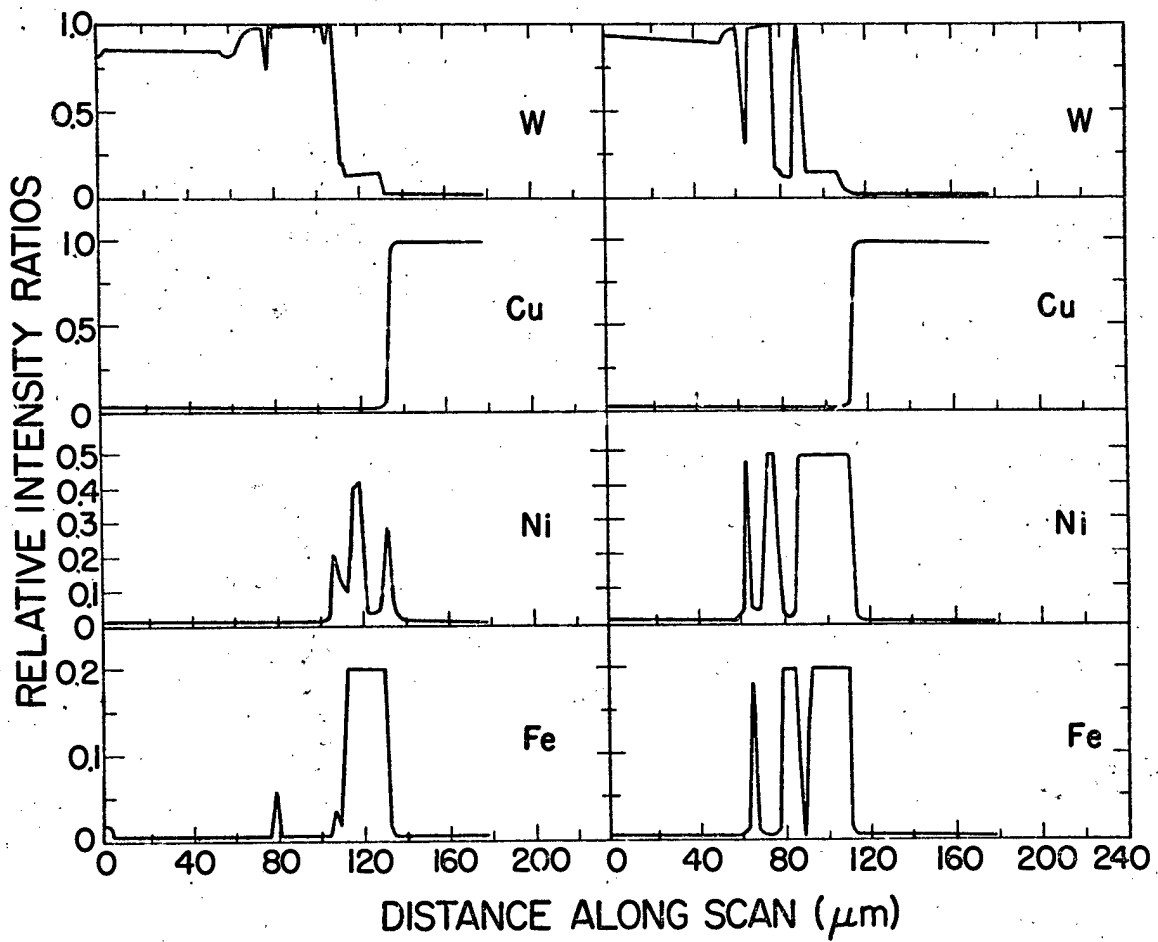
Fig. 6. Microprobe analysis of scans #3 and #4 across composite--copper junction.

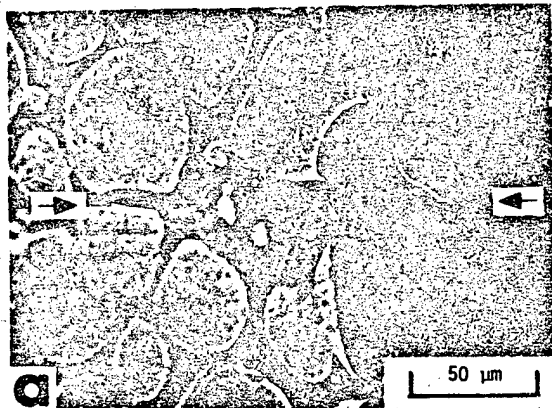
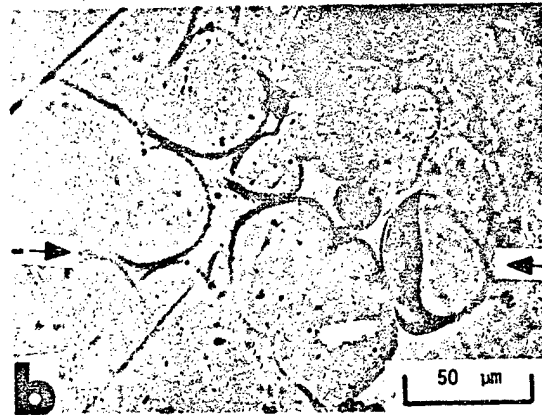
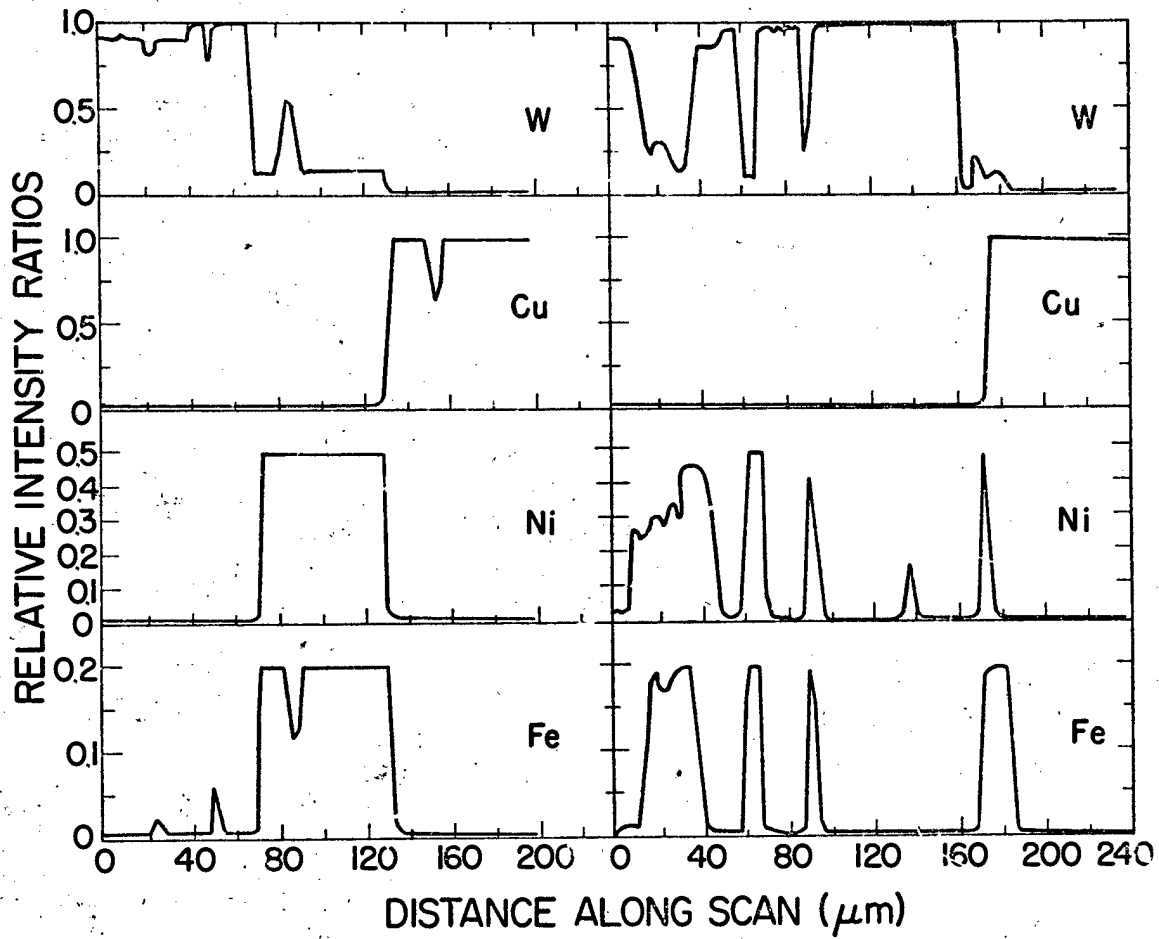
Fig. 7. Microprobe analysis of scans #5 and #6 across composite--copper junction.

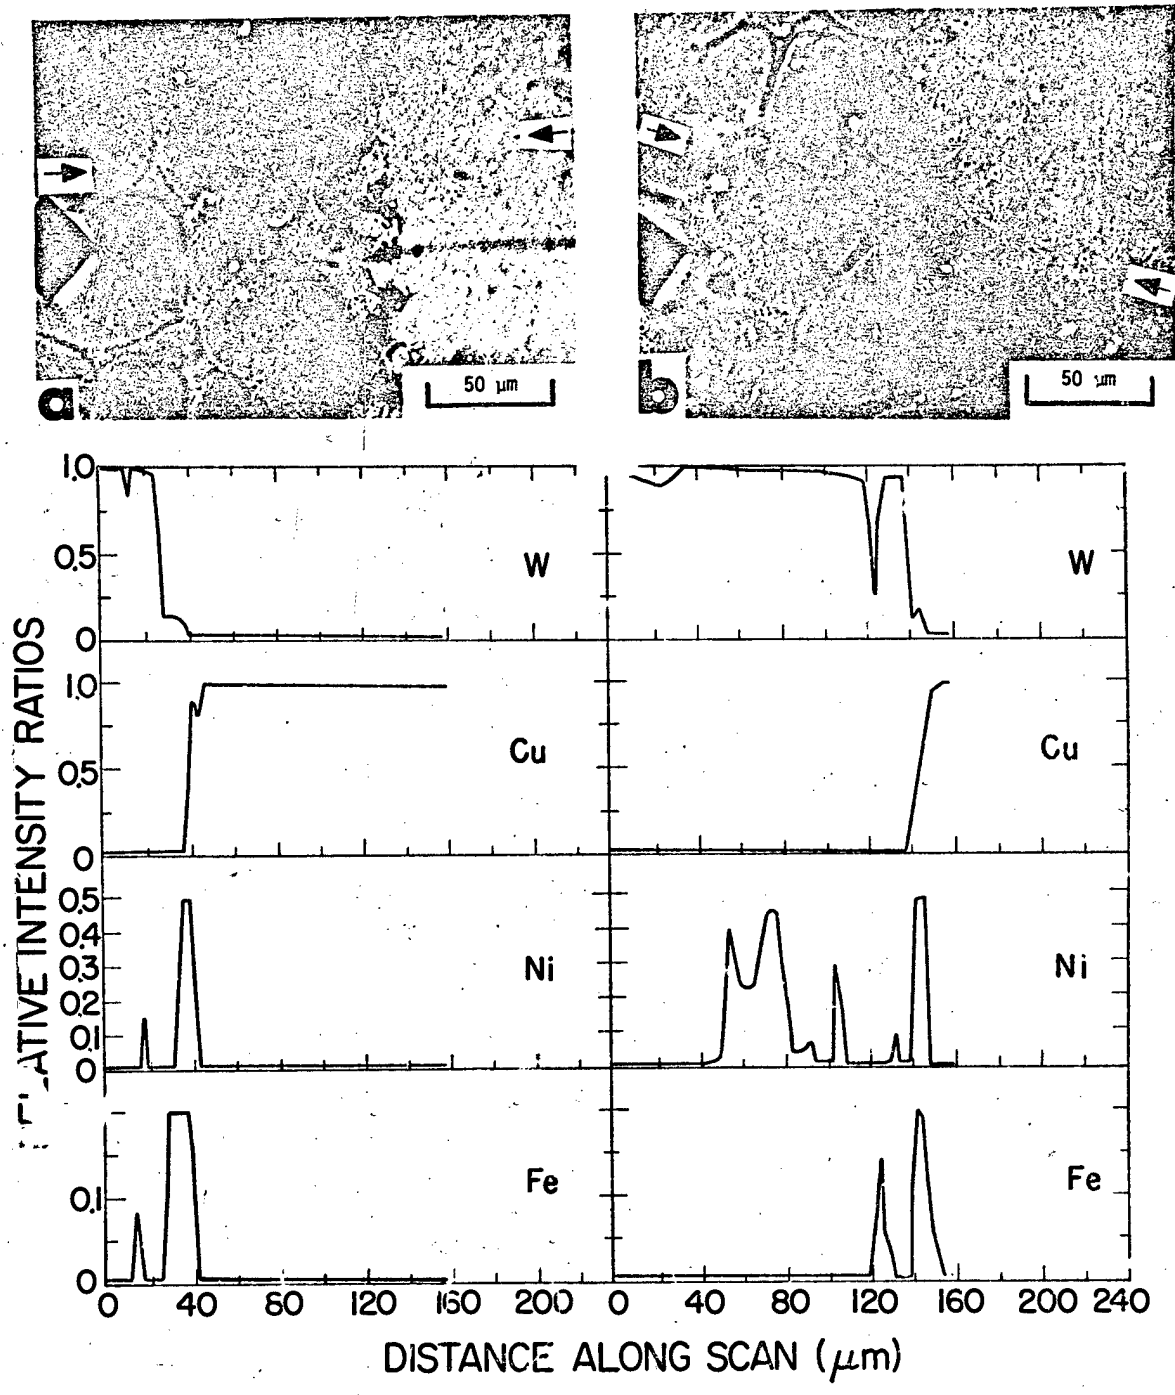
Fig. 8. Microprobe analysis of scans #7 and #8 across composite--copper junction.

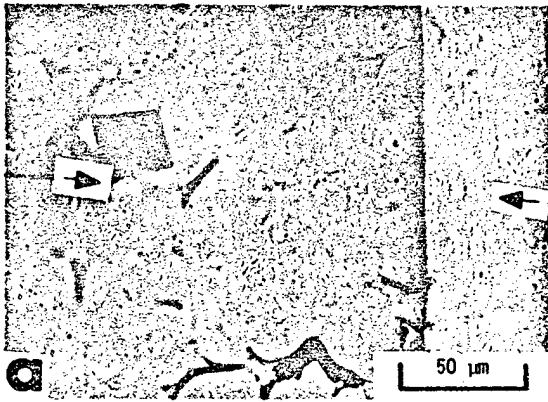
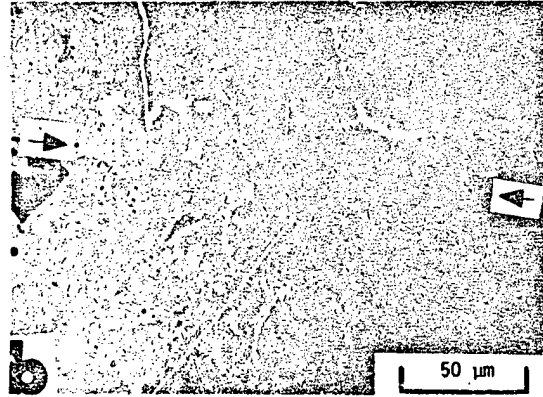
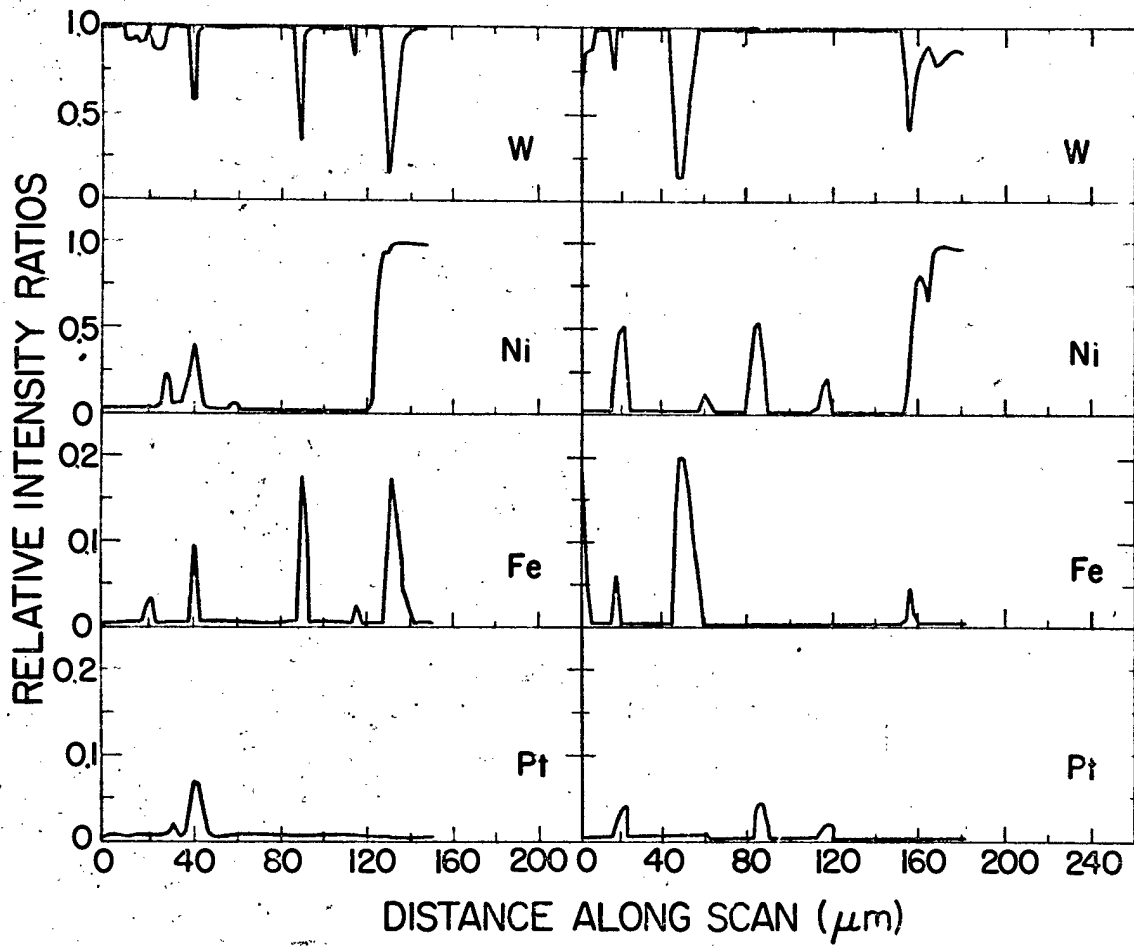
Fig. 9. Microprobe analysis of scans #1 and #2 across composite--nickel junction.

Eight individual microprobe scans for the 94.5% W-3.5% Ni-1.5% Fe-0.5% Pt composite coated with nickel followed by heat-treating in vacuum for 1 h at 1223 K are shown in Figs. 9 through 12. The analytical results show that there is diffusion between the nickel coat and the base composite. In some cases, the diffusion layer seems to be quite wide, but this should be expected in view of the relatively high heat-treatment temperature. However, there is one aspect of the results which may not appear reasonable. In some instances, W diffuses readily into the nickel coat, whereas at other locations, it does not. The same situation occurs with Fe. This behavior is probably similar to that observed in the activated sintering of W with Ni where very rapid diffusion takes place along grain boundaries and along certain crystallographic planes.<sup>3,4</sup>

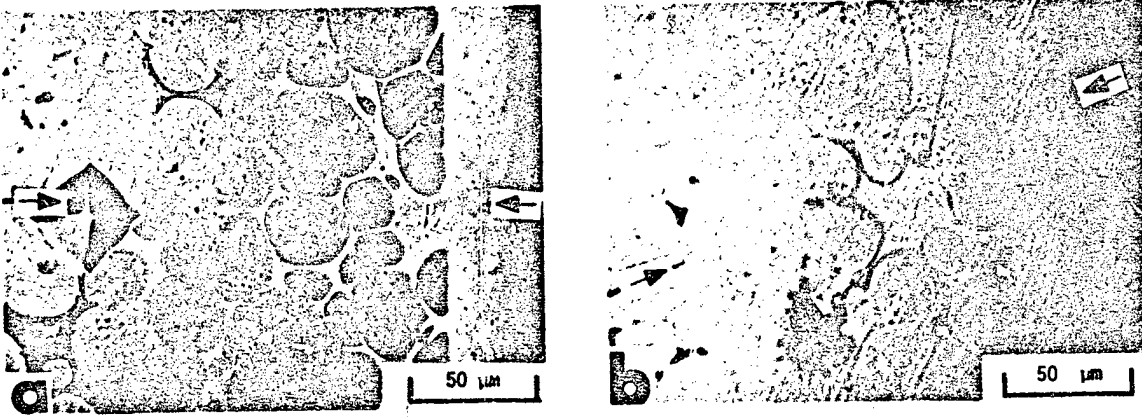
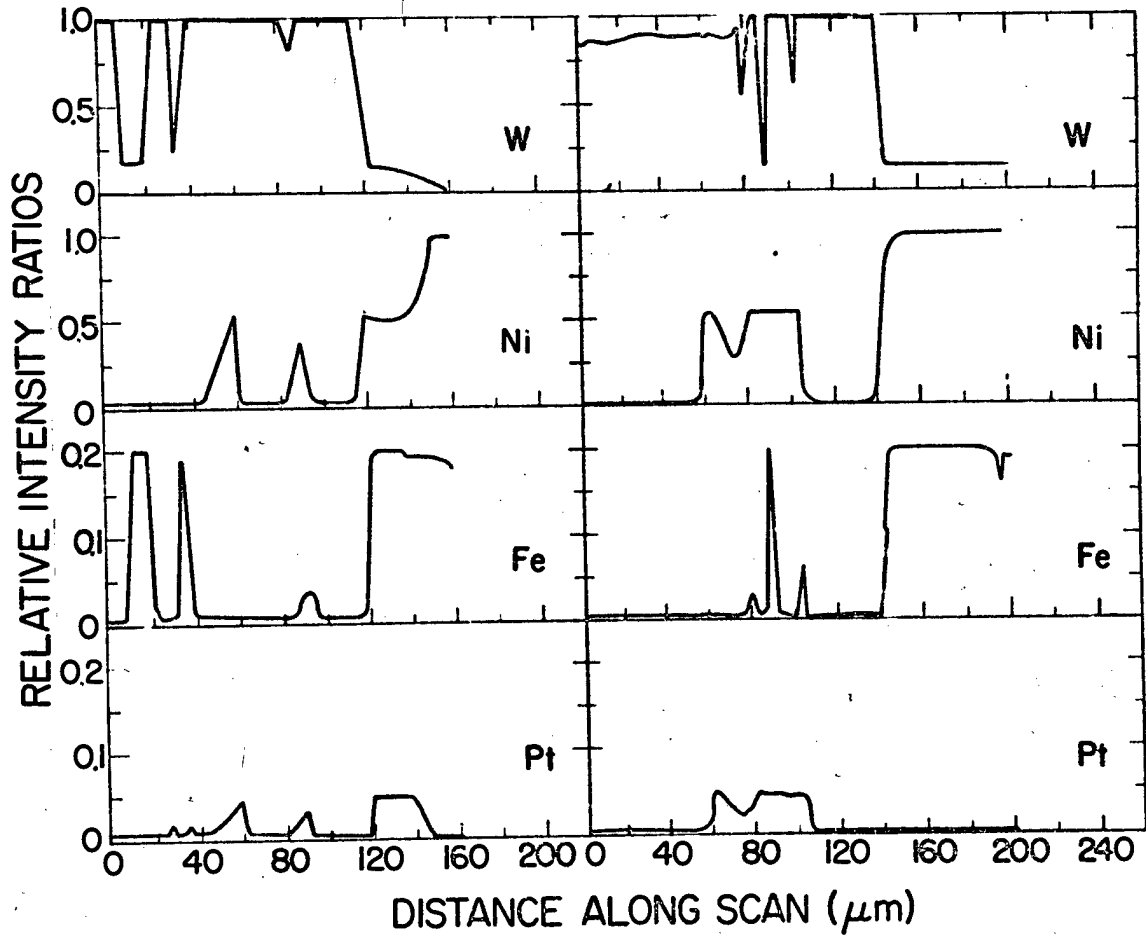
Fig. 10. Microprobe analysis of scans #3 and #4 across composite--nickel junction.

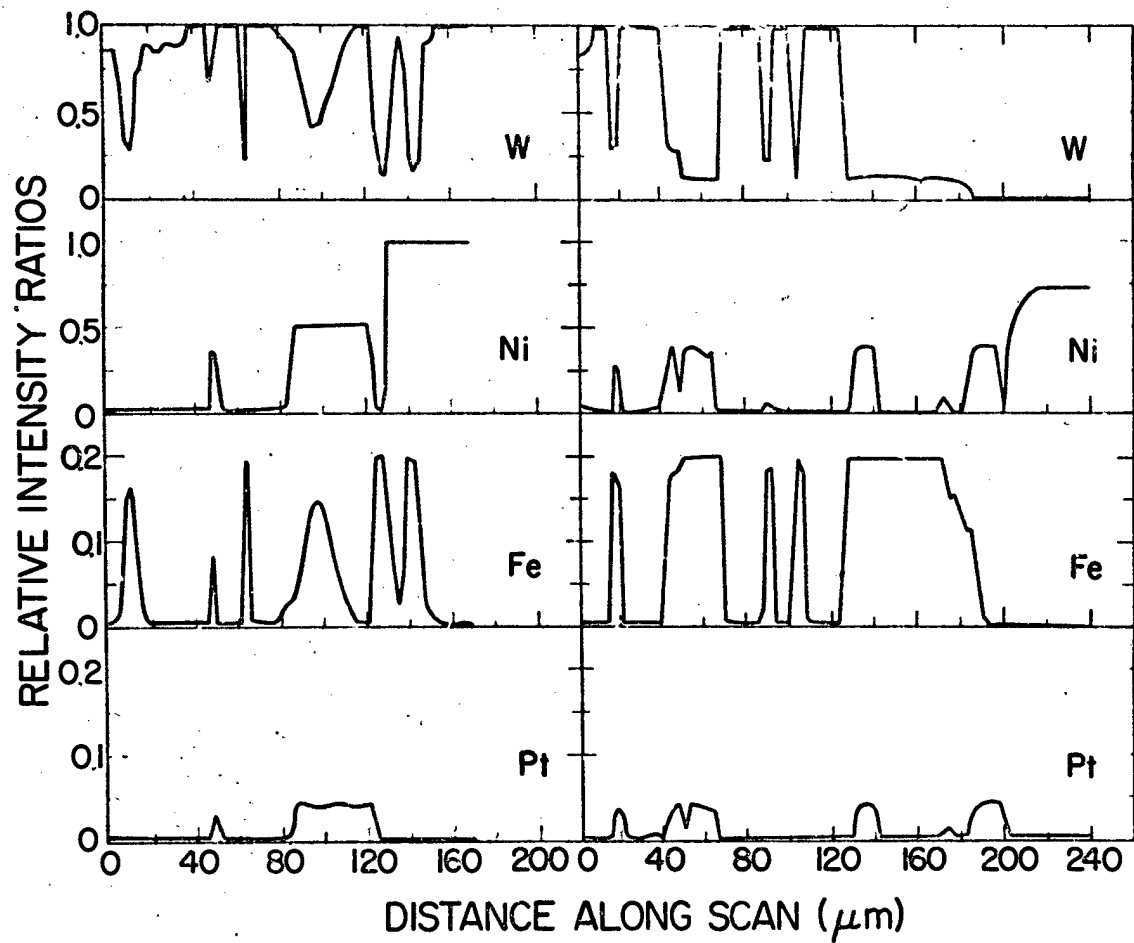
Fig. 11. Microprobe analysis of scans #5 and #6 across composite--nickel junction.

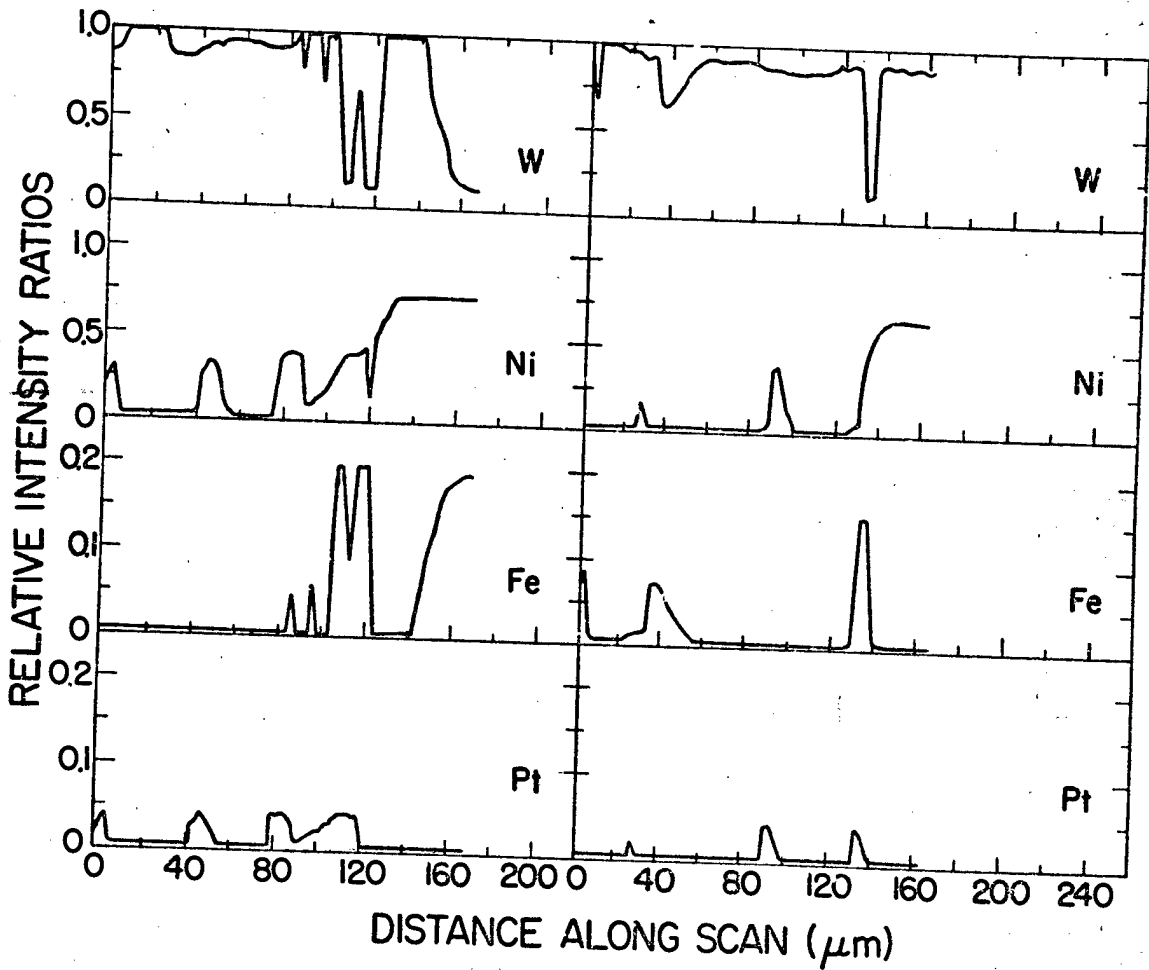
Fig. 12. Microprobe analysis of scans #7 and #8 across composite--nickel junction.
